# Recall Campaign

November 2000  
**FL268A-U**  
(NHTSA OOV-248.001)

### **Subject: TRW Ball Stud End and Socket Assemblies**

### Subject: TRW Ball Stud and Socket Assemblies — Expanded (Tie Rod Ends)

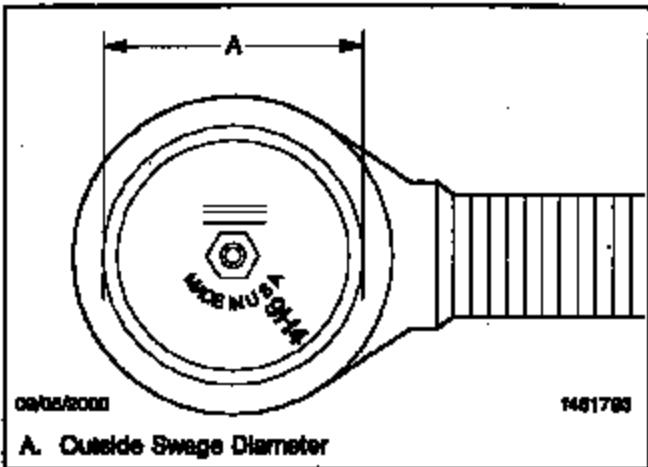
Fig. 2, Measure the Outside Swage Diameter

NOTE: A size 20 socket will measure approximately 1-7/8 inches. Any socket measuring 2-1/8 inches is a size 24 socket and is not part of this campaign.

Table 3 and the sockets are size 20. To identify a size 20 socket, measure the outside swage diameter. See Fig. 2.
